# ENVIRONMENTAL IMPACT ANALYSIS PROCESS

SAIPAN (PACBAR) RADAR MITIGATION STATUS REPORT 31 AUGUST 1990

DEPARTMENT OF THE AIR FORCE

PREPARED BY: ENVIRONMENTAL SOLUTIONS, INC. IRVINE, CALIFORNIA

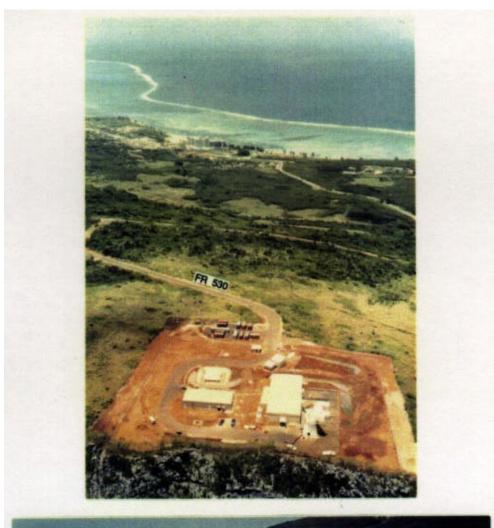
Figure 5.2A

Visual inspection of the erosion control and drainage system revealed potential problems on the south side of Matuis Road, particularly along an area approximately 600 to 800 feet east of Beach Road. It was noted that fill had been placed from the edge of Matuis Road onto the adjacent land in such a manner that runoff would be diverted onto the road. Sediment would then be deposited onto Matuis Road and into the erosion control system. It was further noted that, if left alone, the road shoulder would eventually erode (see Appendix C.2, Memo of 6 June 1990).

Looking North at Intersection of Beach and Matuis Roads
